September 10, 2014

Steve Pamperin, City Planner
City of Charleston
520 Jackson Ave.
Charleston, IL 61920

Re: Lincoln Elementary School Monitoring
Madison Ave
Charleston, IL 61920

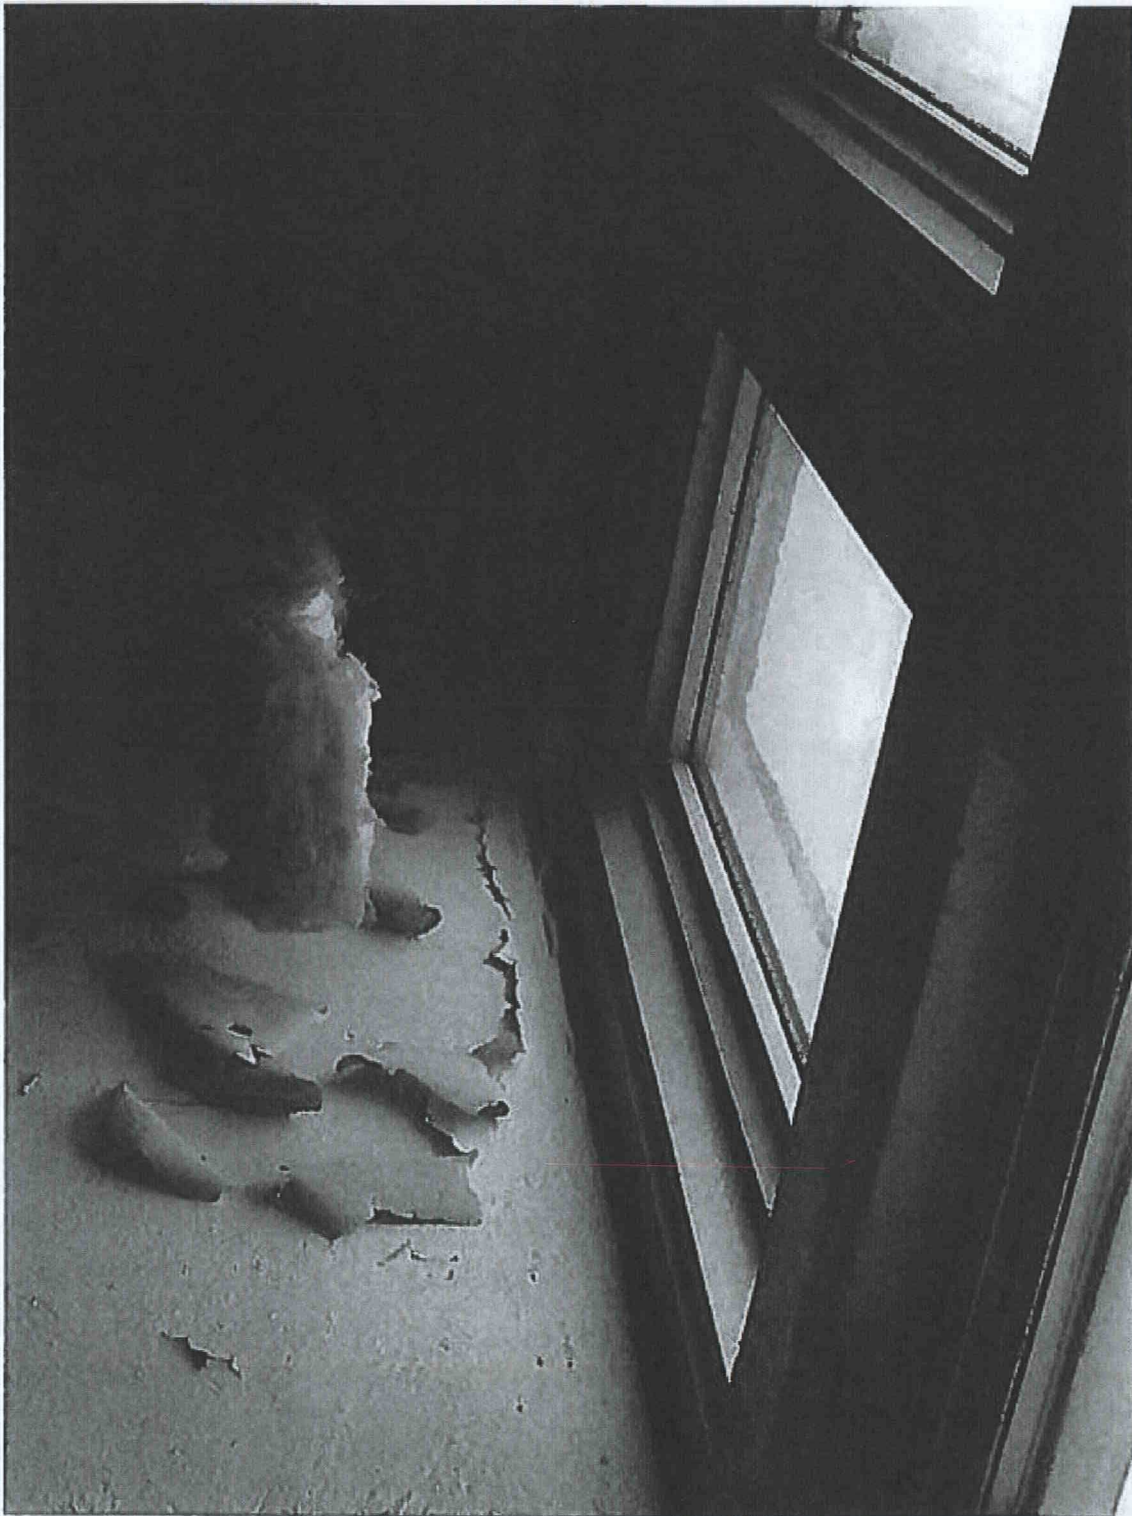
From both the east and west stairwells on each end of the building, it can be readily seen that the end masonry walls are separating from the interior walls and framing (Figures 7 and 8). In the east end stairwell the interior wall has a large crack in the top where the end wall frames in to the roof and wall forming the stairwell. Similarly, in the west end stairwell a gap can be seen between the end wall and roof framing at the top.

Figure 8 – View in west end stairwell of end wall pulling away from building.

It is recommended that the cracking in the east and west end stairwells be monitored to determine if these walls are falling away from the building. The east end wall poses a serious threat to the garage and residence adjacent to it.
